HISTORIC AMERICAN BUILDINGS SURVEY
INVENTORY

2. NAME *Orrin Thompson Mansion*

DATE OR PERIOD *1832*
STYLE *Greek Revival*
ARCHITECT
BUILDER *Orrin Thompson*

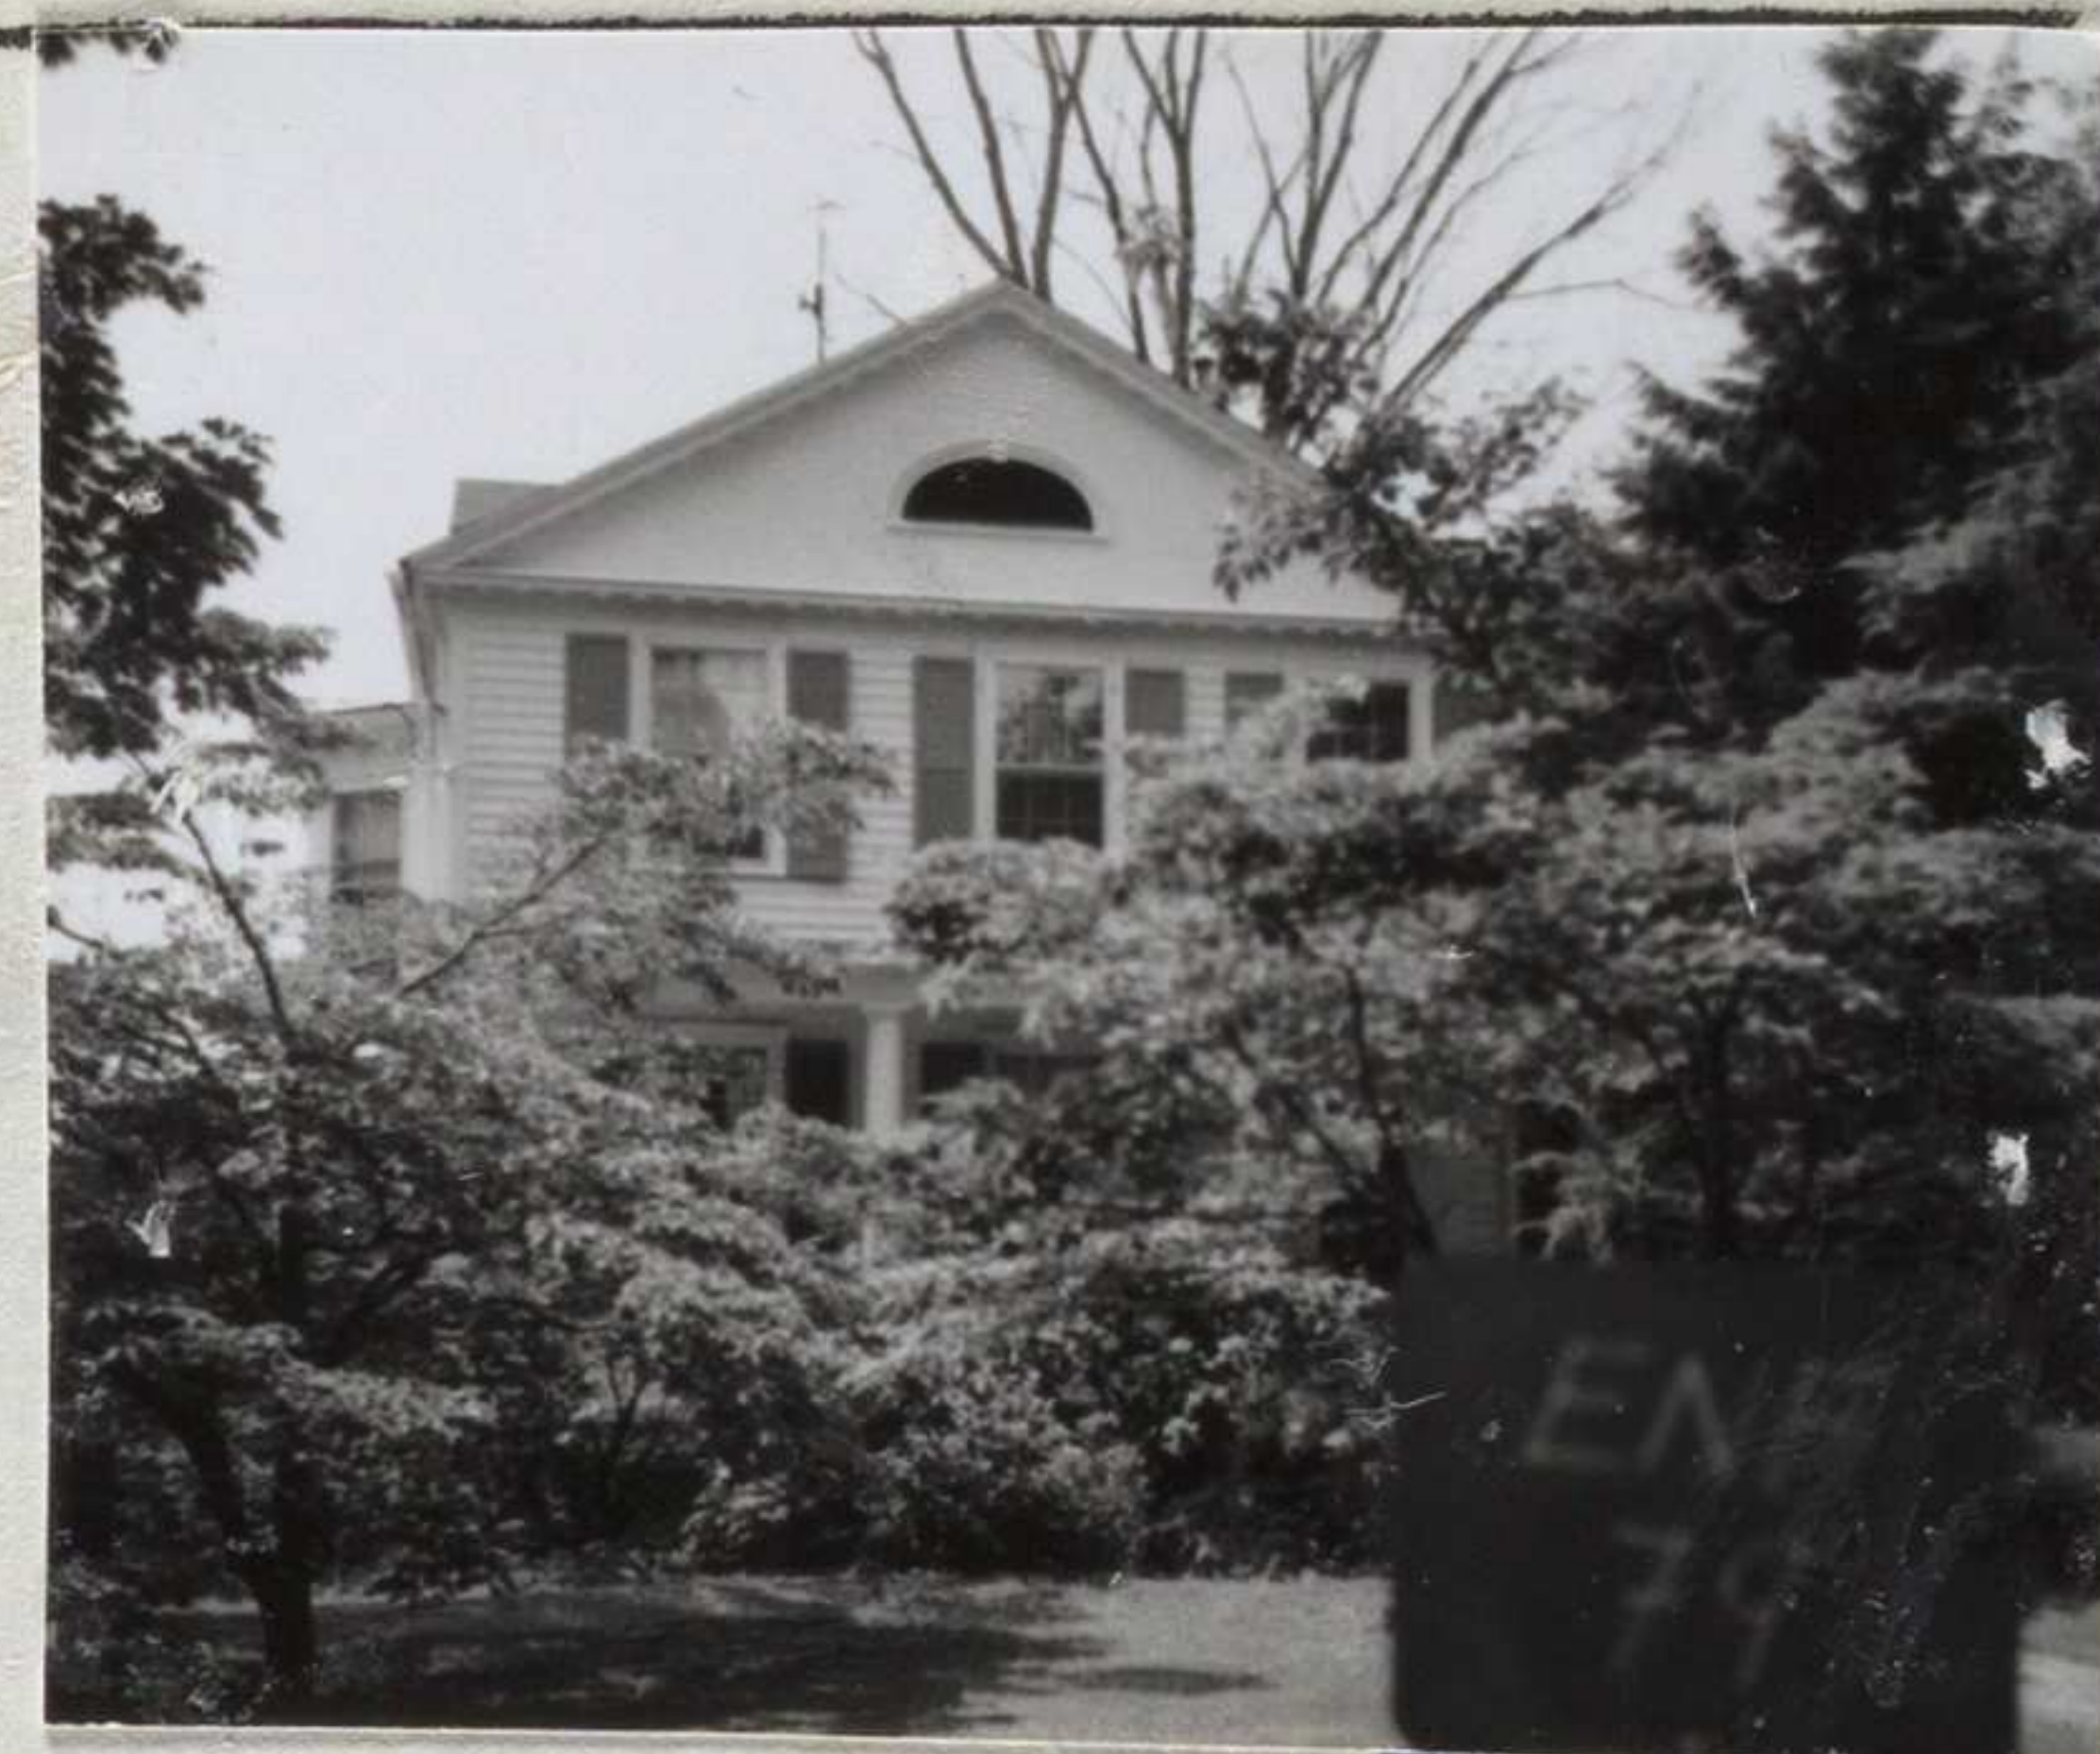
7. PHOTOGRAPH *Enf 79*

This house is of the typical Greek Revival type of three bays with a brownstone foundation and shallow pitched roof. The tympanum is plain boarded and bears a semi-circular window. The cornice around the pediment and under the side eaves is ornamented with guttoe blocks. The doorway is a curiosity in that the pilasters framing the door are heavily tapered in at both top and bottom at the hand of an inventive carpenter who "improved" on the classic model.

Endangered *No* Interior *Good* Exterior *Good*

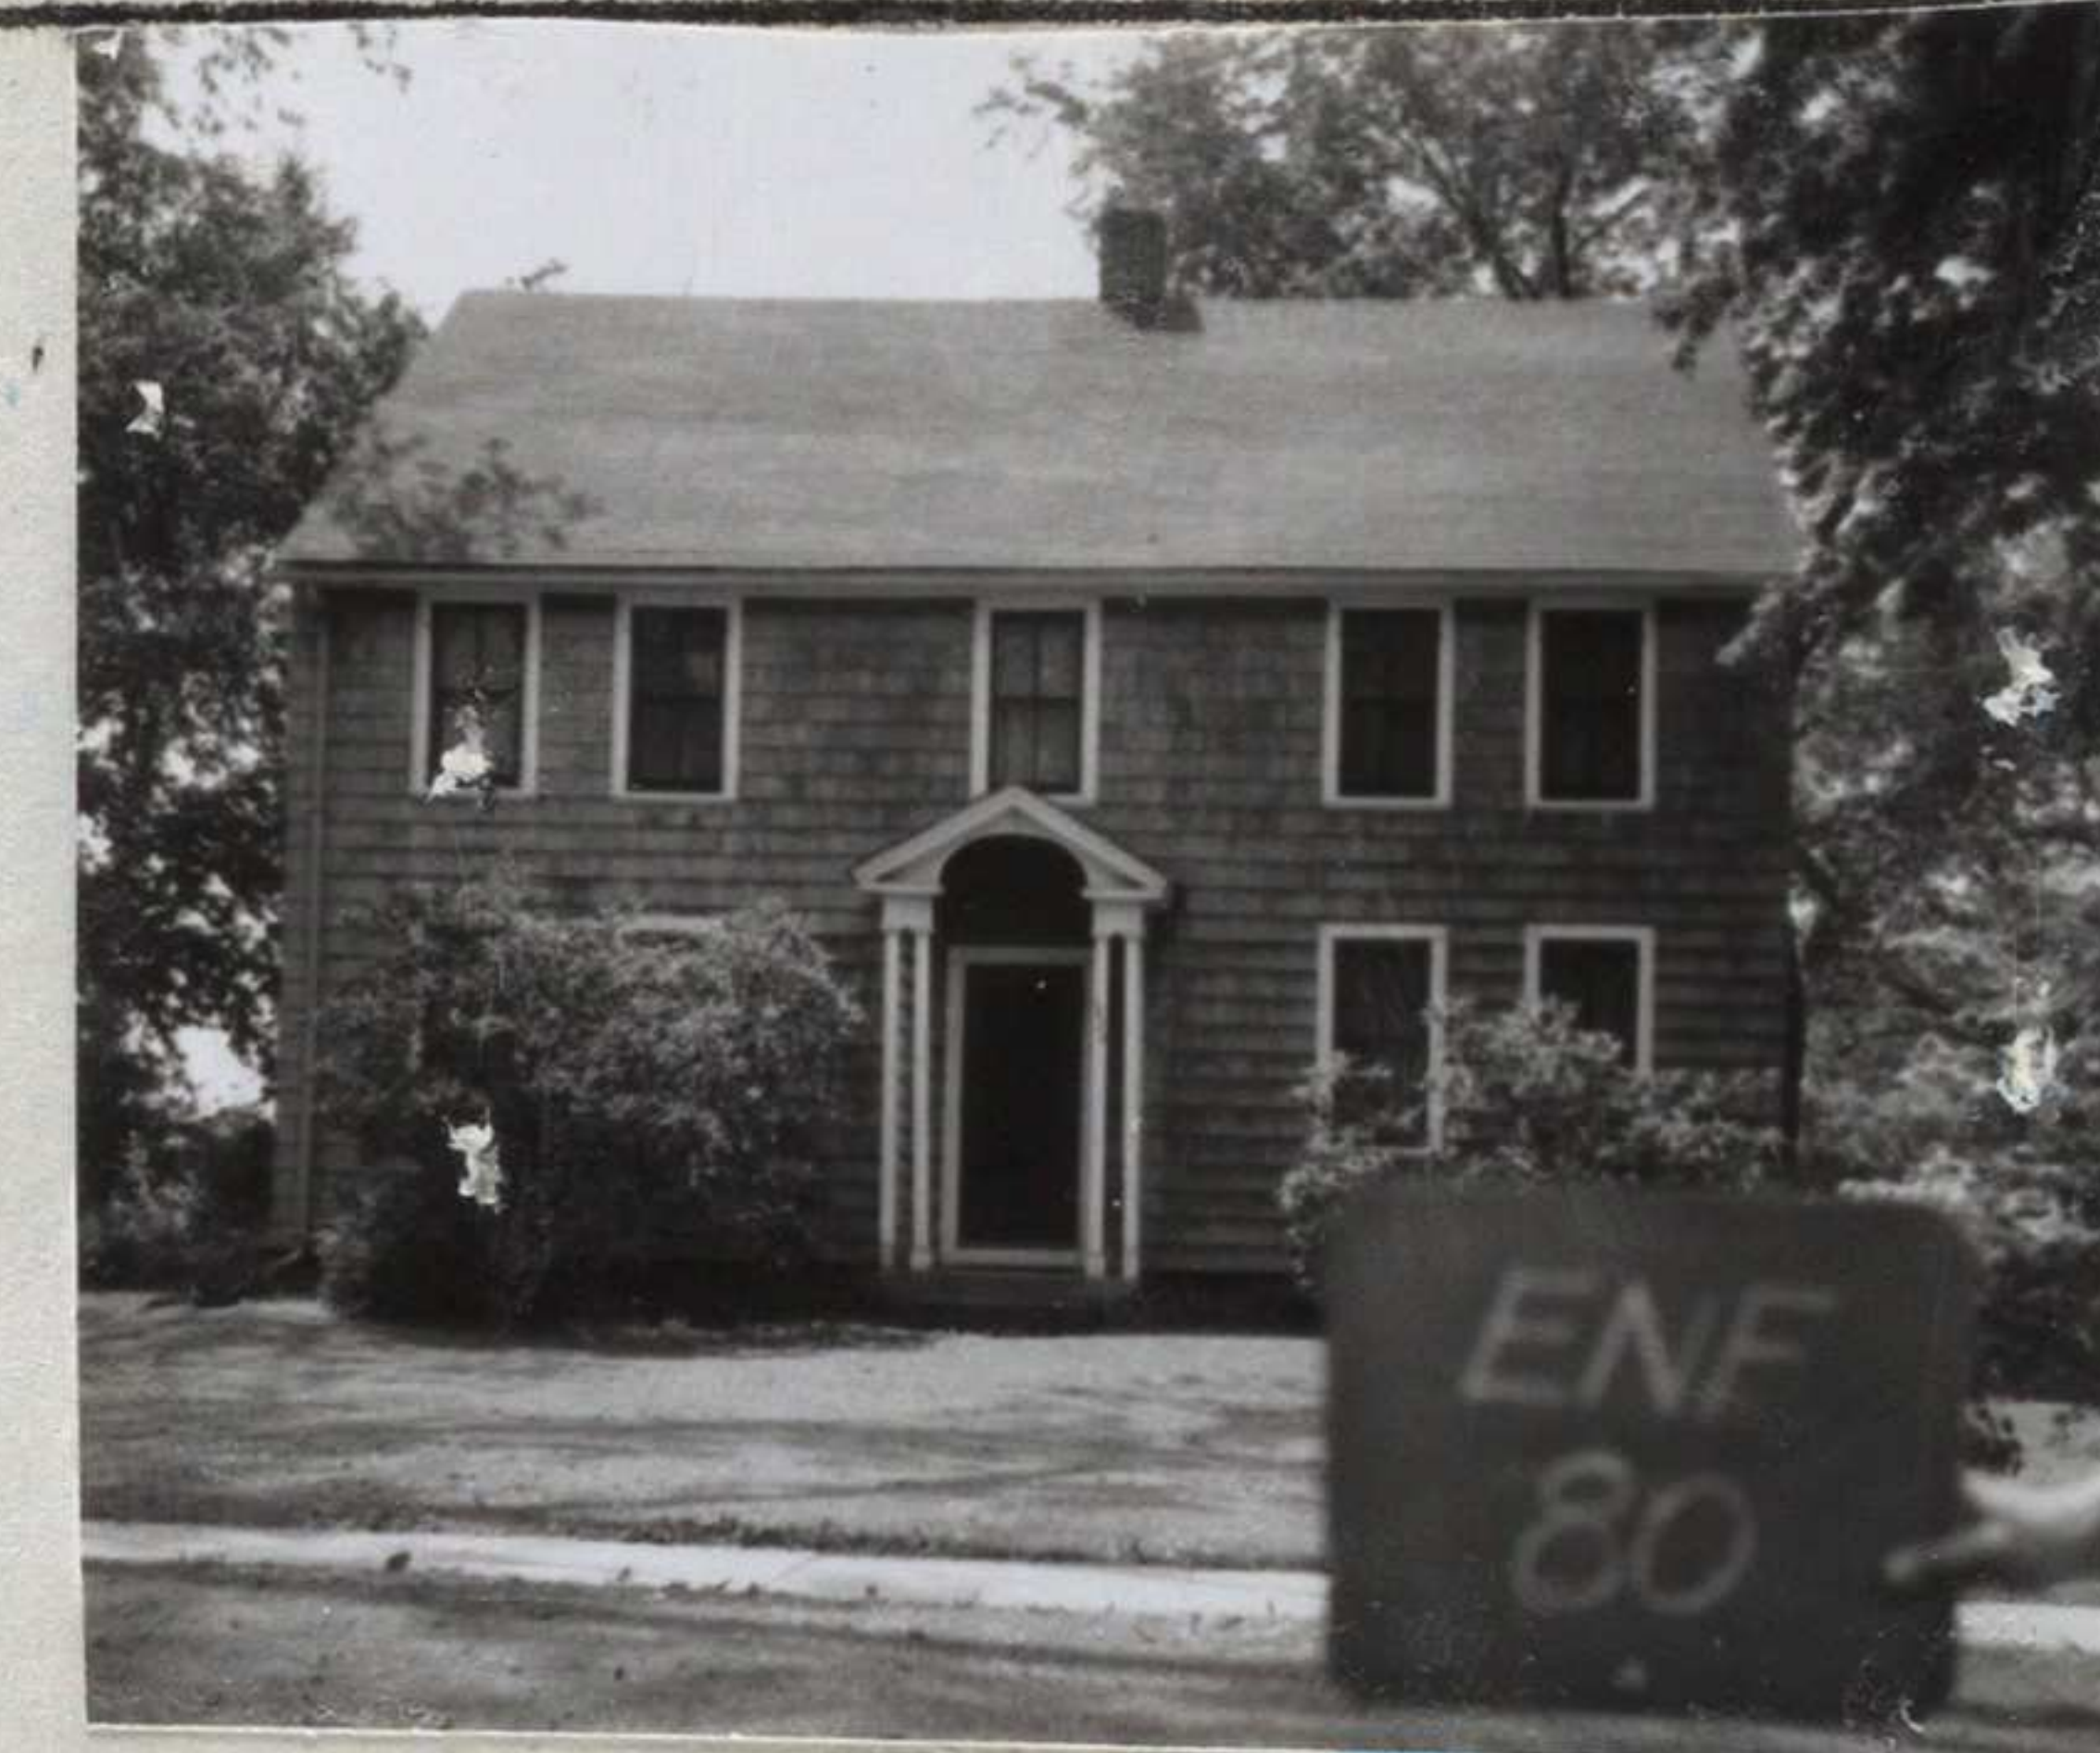
<p>7. PHOTOGRAPH <i>ENS 80</i></p>

<p>1. STATE <i>Ct</i> COUNTY <i>Hartford</i> TOWN <i>Enfield</i> VICINITY STREET NO. <i>1424</i> <i>Enfield Street</i></p> <p>ORIGINAL OWNER <i>Benjamin Pease</i> ORIGINAL USE <i>Residence</i> PRESENT OWNER <i>J. Murray Prior (Mrs.)</i> PRESENT USE <i>Residence</i> WALL CONSTRUCTION <i>shingle</i> NO. OF STORIES <i>2</i></p>	<p style="text-align: center;">49-39</p> <p style="text-align: center;">HISTORIC AMERICAN BUILDINGS SURVEY INVENTORY</p> <p>2. NAME <i>Benjamin Pease House</i></p> <p>DATE OR PERIOD <i>1700</i> STYLE <i>Georgian Colonial</i> ARCHITECT BUILDER</p> <p>3. FOR LIBRARY OF CONGRESS USE</p>
<p>4. NOTABLE FEATURES, HISTORICAL SIGNIFICANCE AND DESCRIPTION</p> <p style="text-align: right;">OPEN TO PUBLIC <i>No</i></p> <p><i>One of the oldest houses in Enfield, this dwelling has recently had architecturally unsympathetic but practically good care. The house has the standard features of its period — brownstone foundation, five bay facade, steep pitched roof and an early rear lean-to. Unfortunately the door, doorway and windows are new as is the shingling over the original clapboards. Inside the original paneled front stair winds in front of the chimney. Some paneling is left in the two front rooms. The boorning room is now part of the kitchen and the rear stair is rerouted. The corner cupboard in the front right room is the finest interior — over</i></p> <p>5. PHYSICAL CONDITION OF STRUCTURE Endangered ? Interior <i>Fair</i> Exterior <i>Fair</i></p>

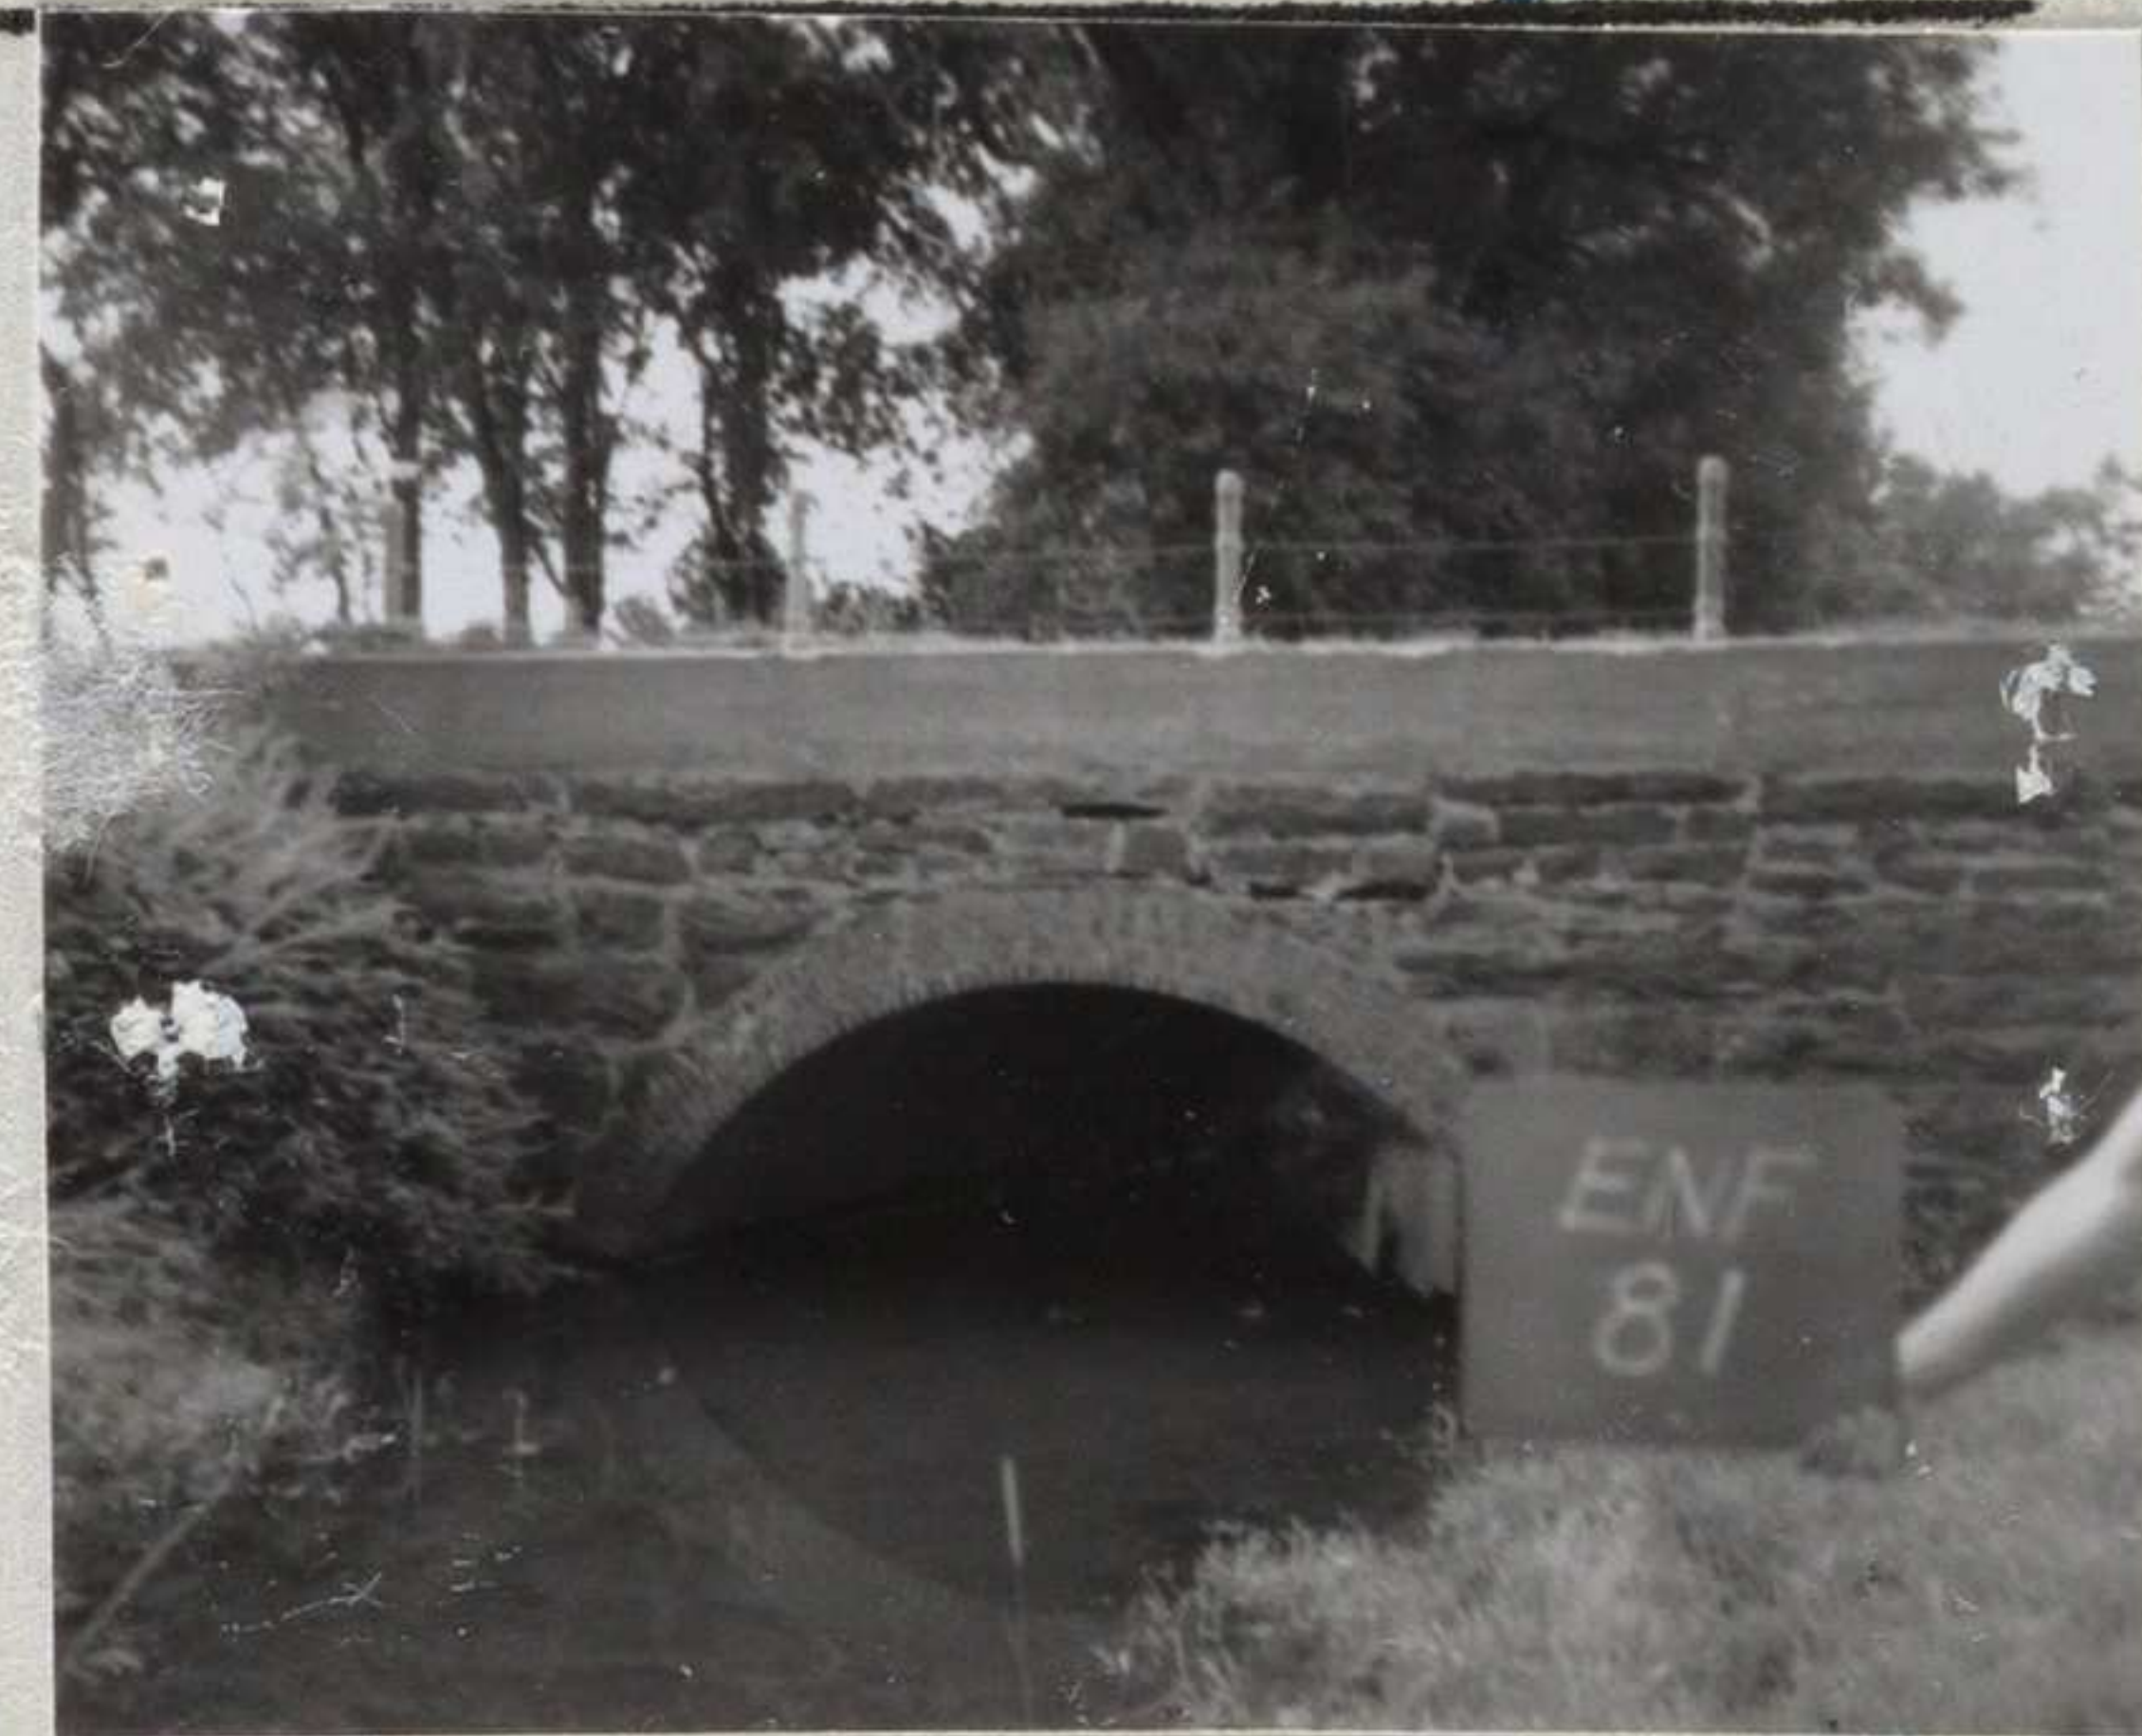
7. PHOTOGRAPH *Enf 81*

Exterior *good*

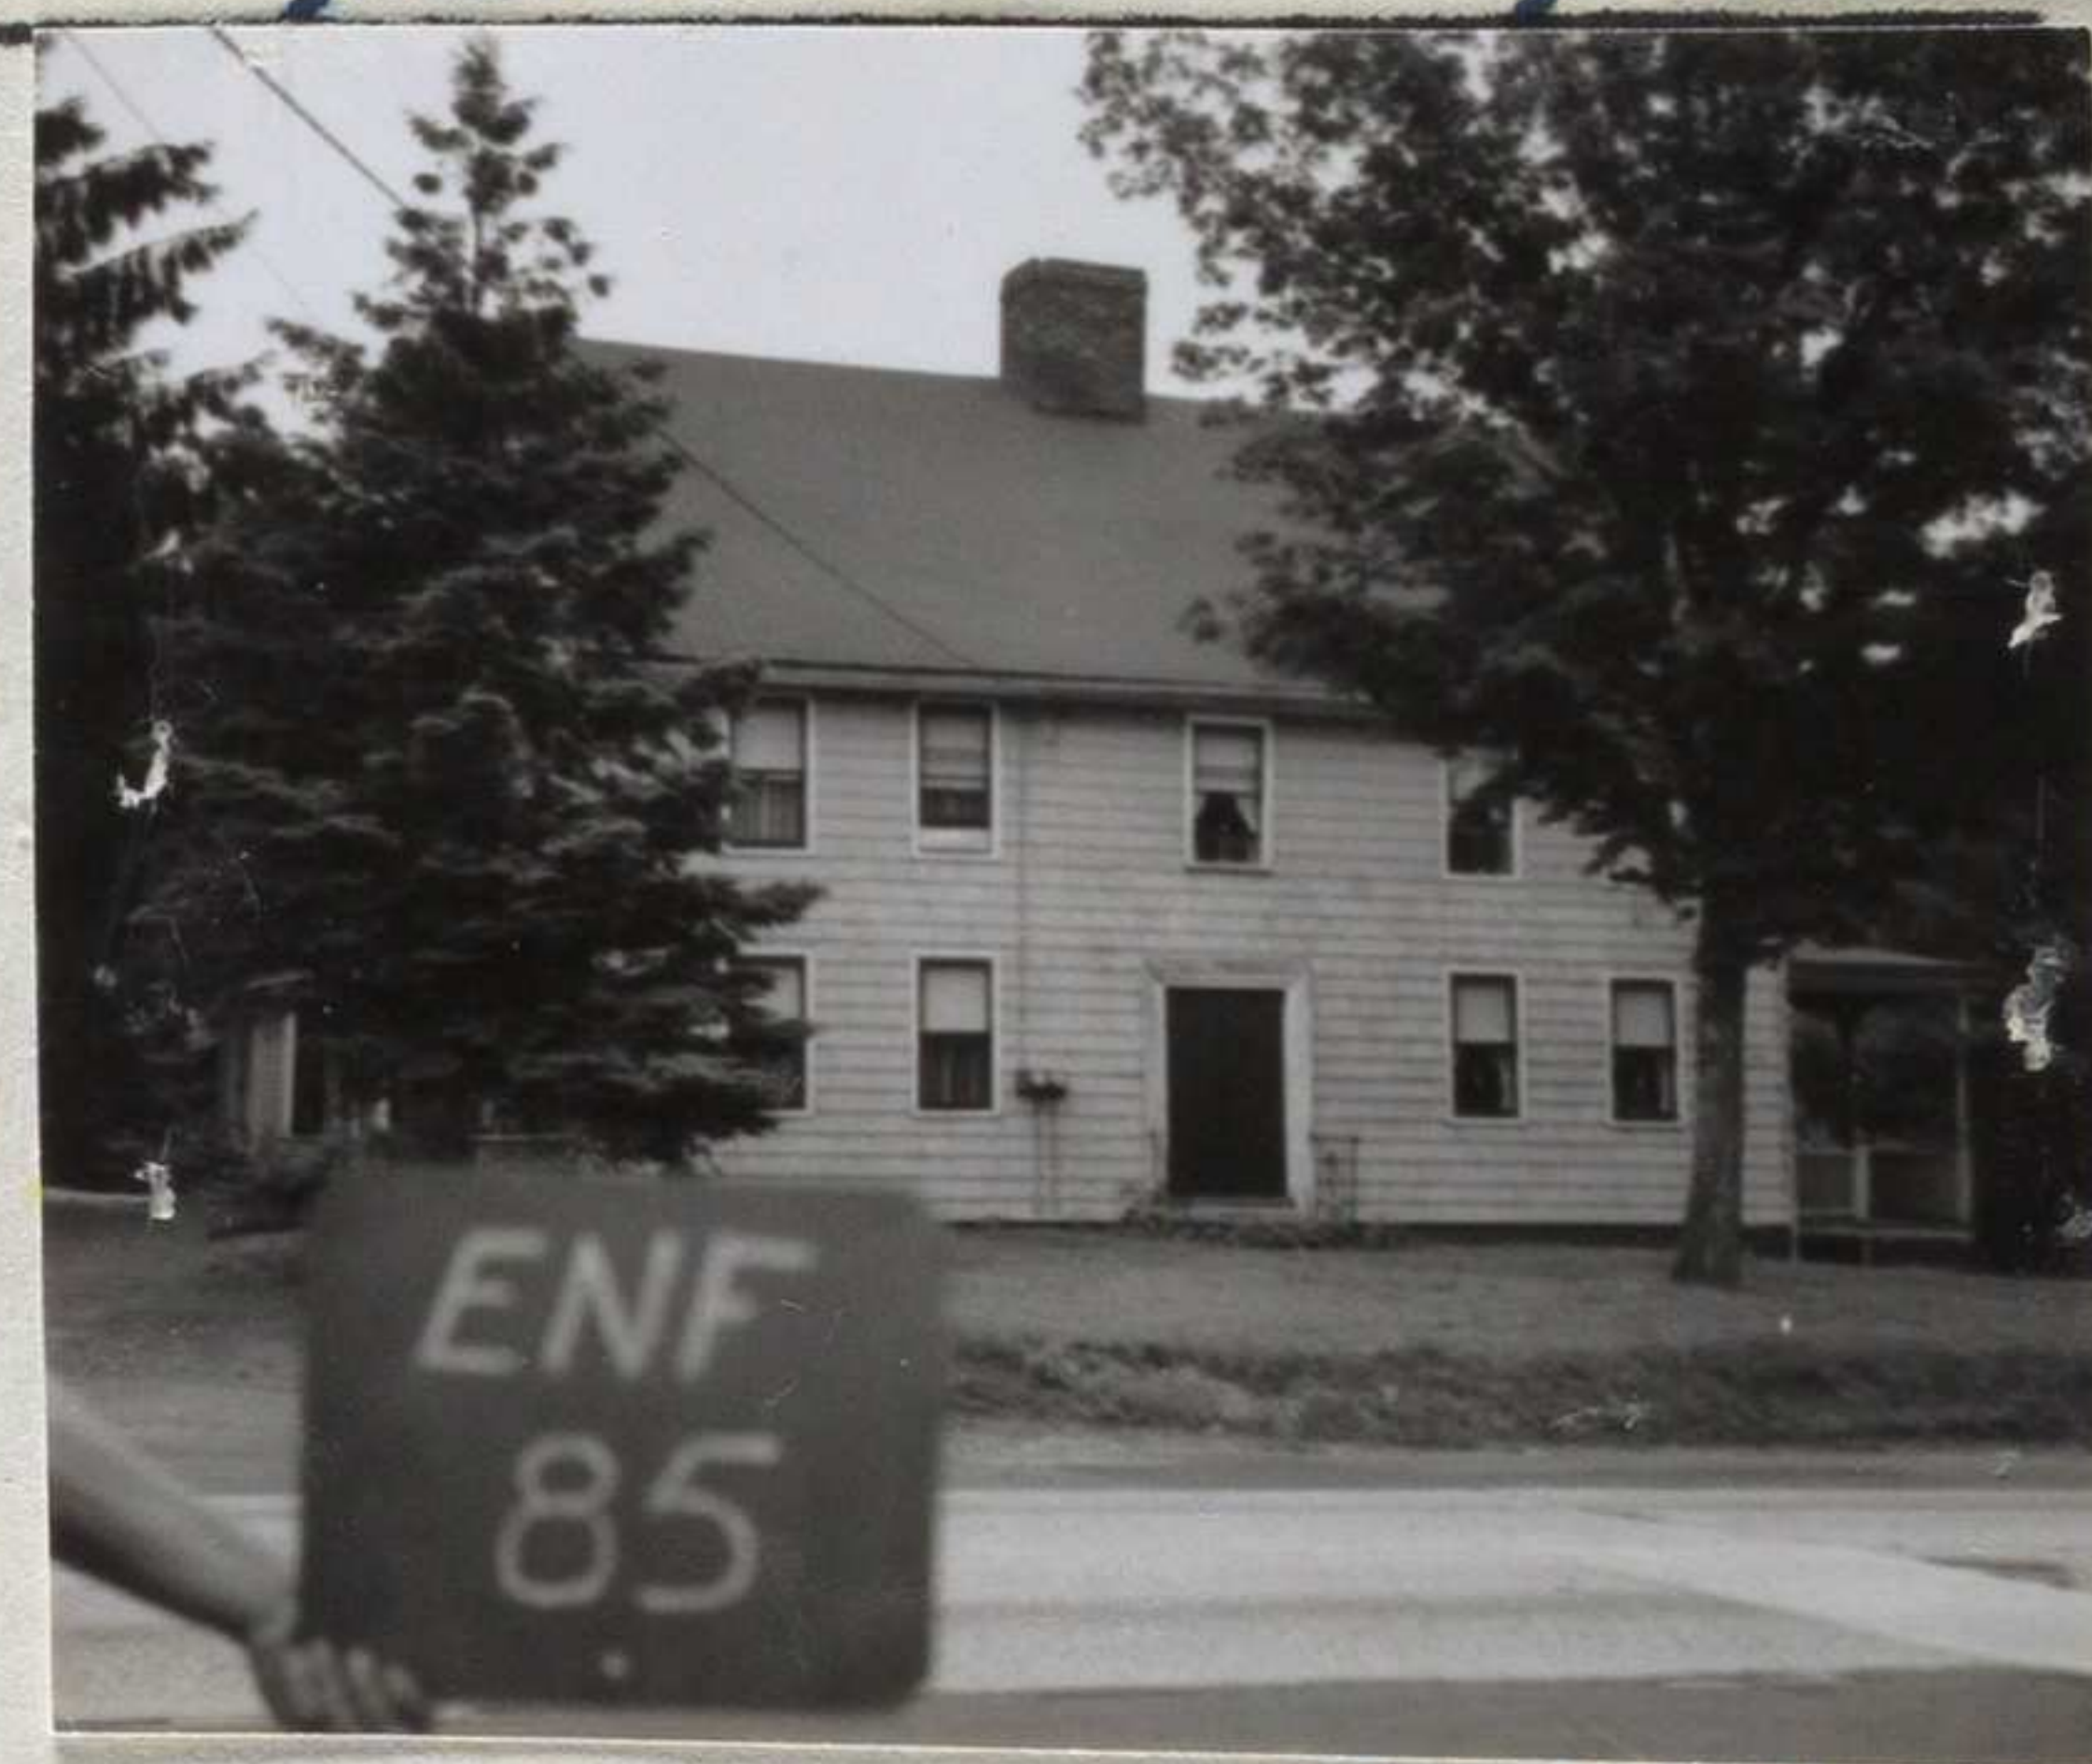
7. PHOTOGRAPH *Enf 85*

This old building is in serious danger of being destroyed. It is a fine example even in its present condition and such an act would be extremely regrettable. The five bay house surmounts a brownstone foundation. The roof is steep and has its original central chimney. The attic level projects slightly. The windows are new but the simply molded double front door is completely original. There is also a coffin door to the south.

Endangered *Yes* Interior *poor?* Exterior *poor*

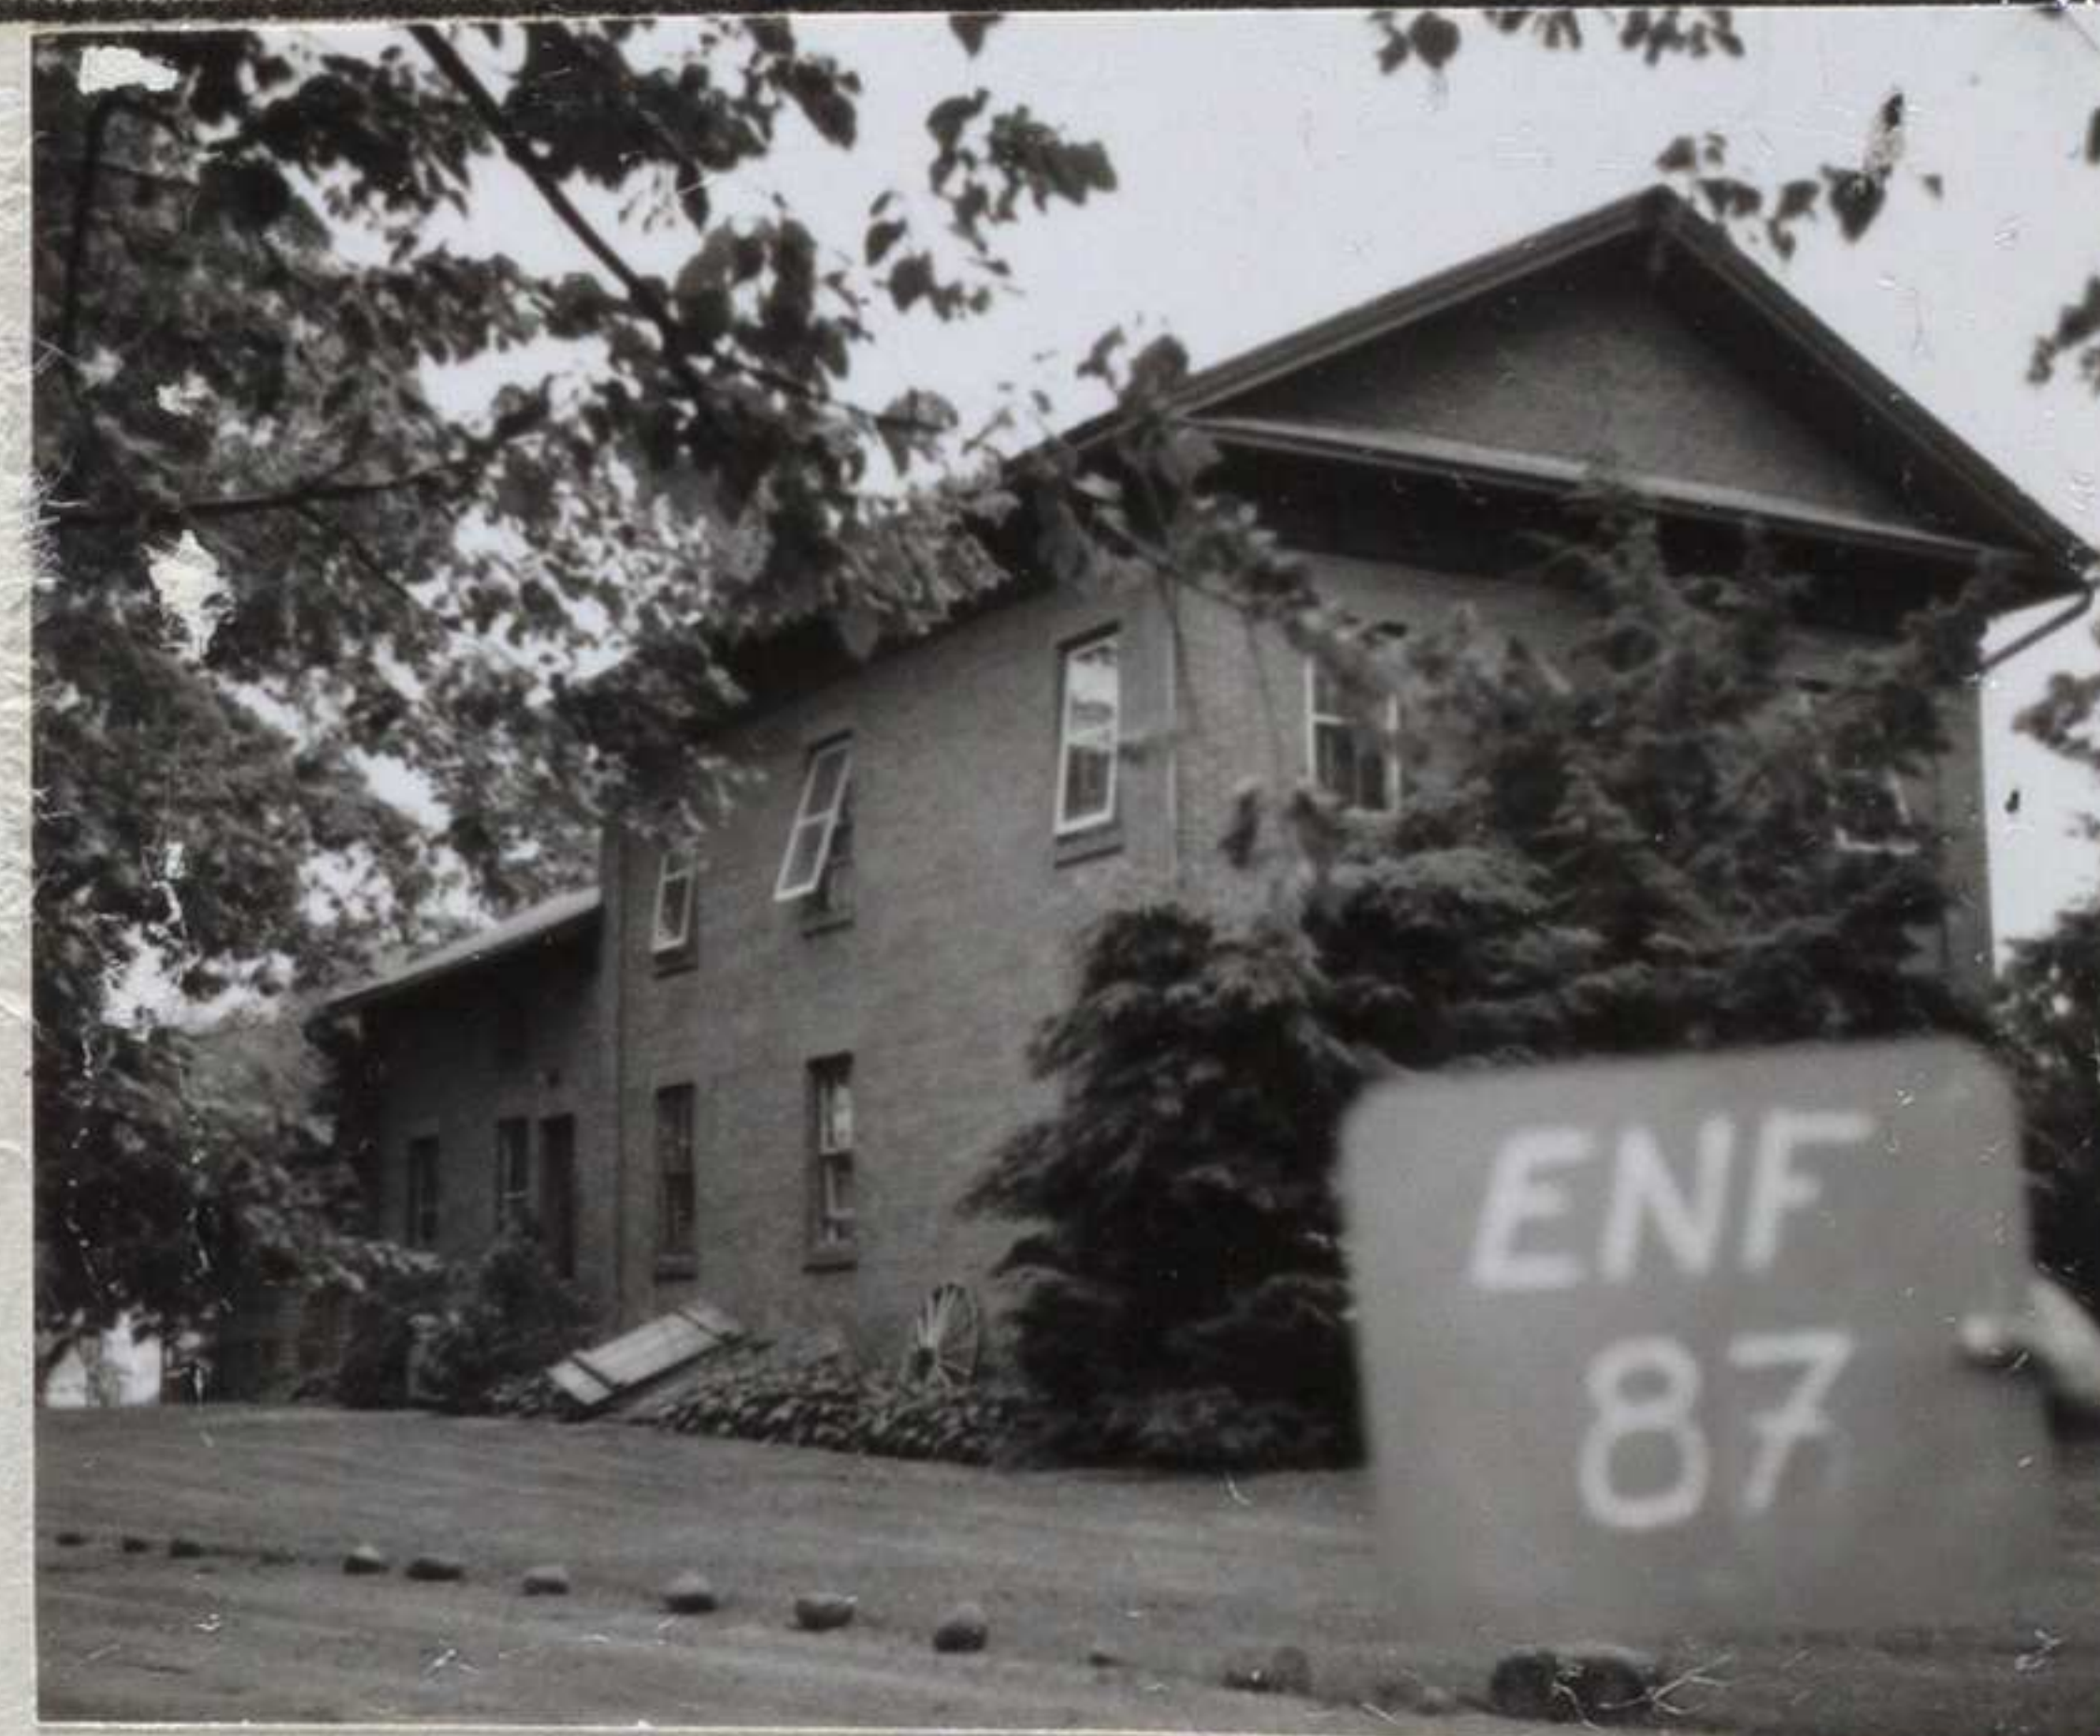
7. PHOTOGRAPH *Enf 87*

*This house not only has brick foundation
walls but stylized brick pilasters and entablature.
There are three facade bays with 6/6 windows
and a doorway with sidelights. The bracketed
pediment section is formed by a shallow pitched
roof and no window breaks the tympanum.*

Endangered *No* Interior *fair* Exterior *good*
